Why Indeed Did the WTC Buildings Completely Collapse?

By Dr. Steven E. Jones

ABSTRACT

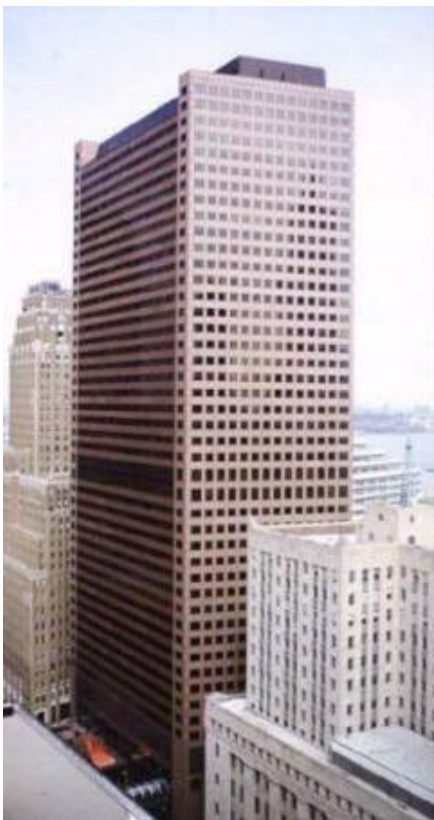
WTC 7: 47 - Story, steel-frame building..

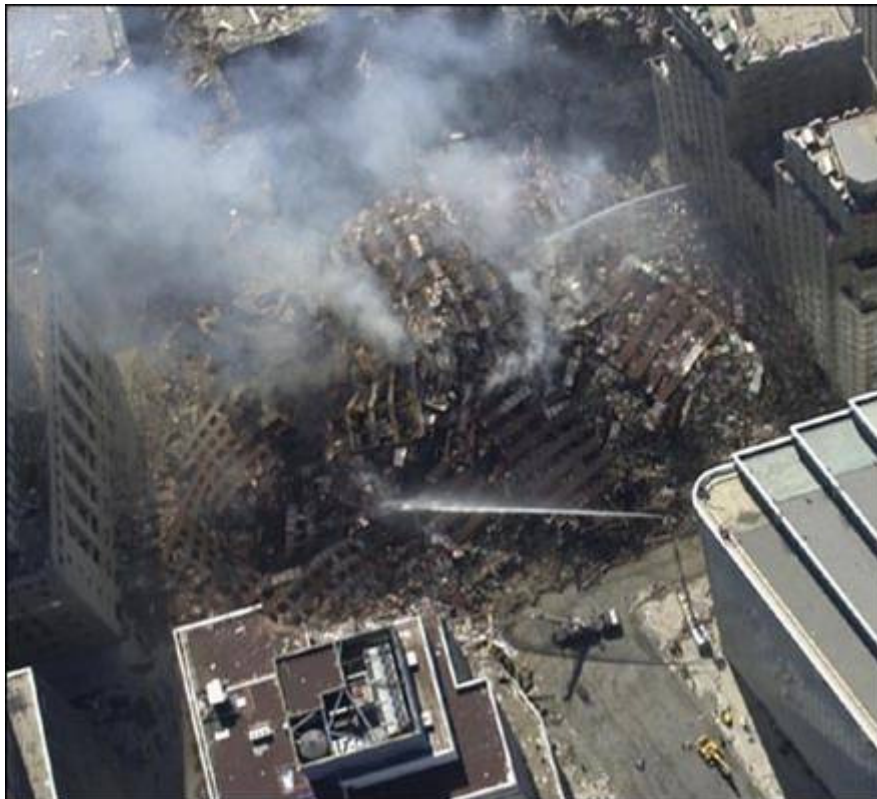
WTC 7 collapsed completely on 9/11/2001, primarily onto its own footprint.

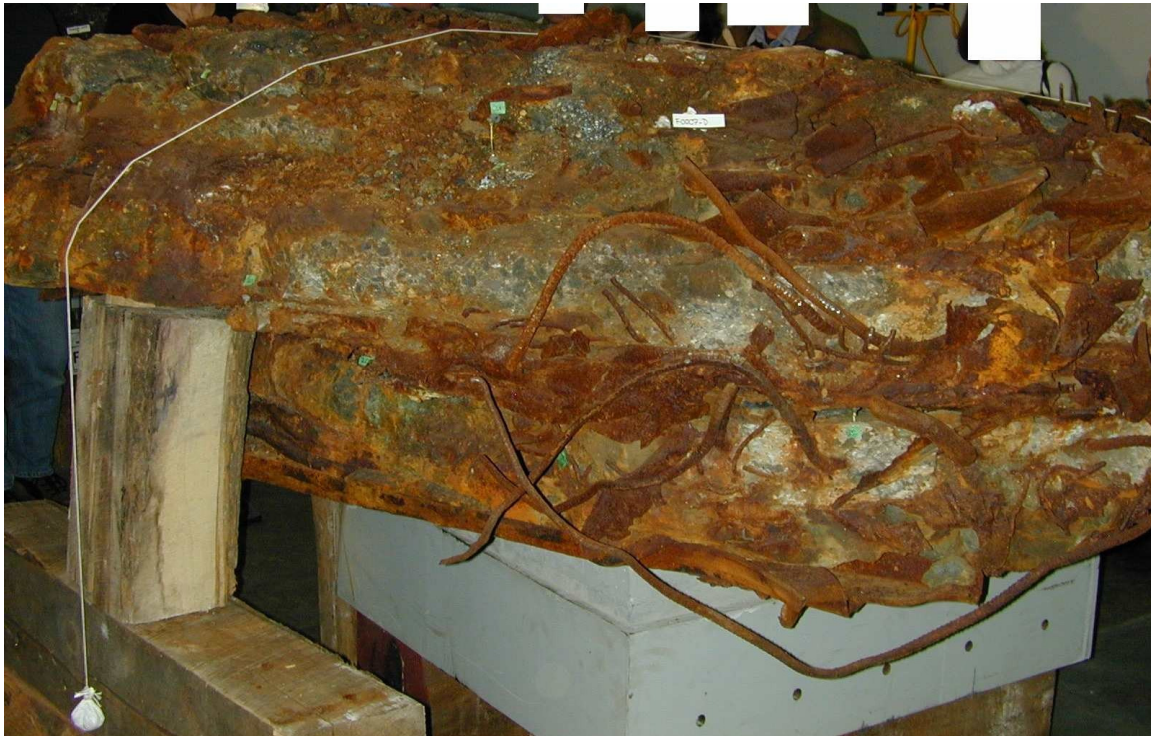
The abundance of iron (as opposed to aluminum) in this material is indicated by the reddish rust observed. When a sample is obtained, a range of characterization techniques will quickly give us information we seek. X-ray energy dispersive spectrometry (XEDS) will yield the elemental composition, and electron energy-loss spectroscopy will tell us the elements found in very small amounts that were undetectable with XEDS. Electron-backscattered diffraction in the scanning electron microscope will give us phase information; the formation of certain precipitates can tell us a minimum temperature the melt must have reached. We will endeavor to obtain and publish these data, whatever they reveal.

The following photograph has become available, evidently showing the now-solidified metal with entrained material, stored (as of November 2005) in a warehouse in New York:

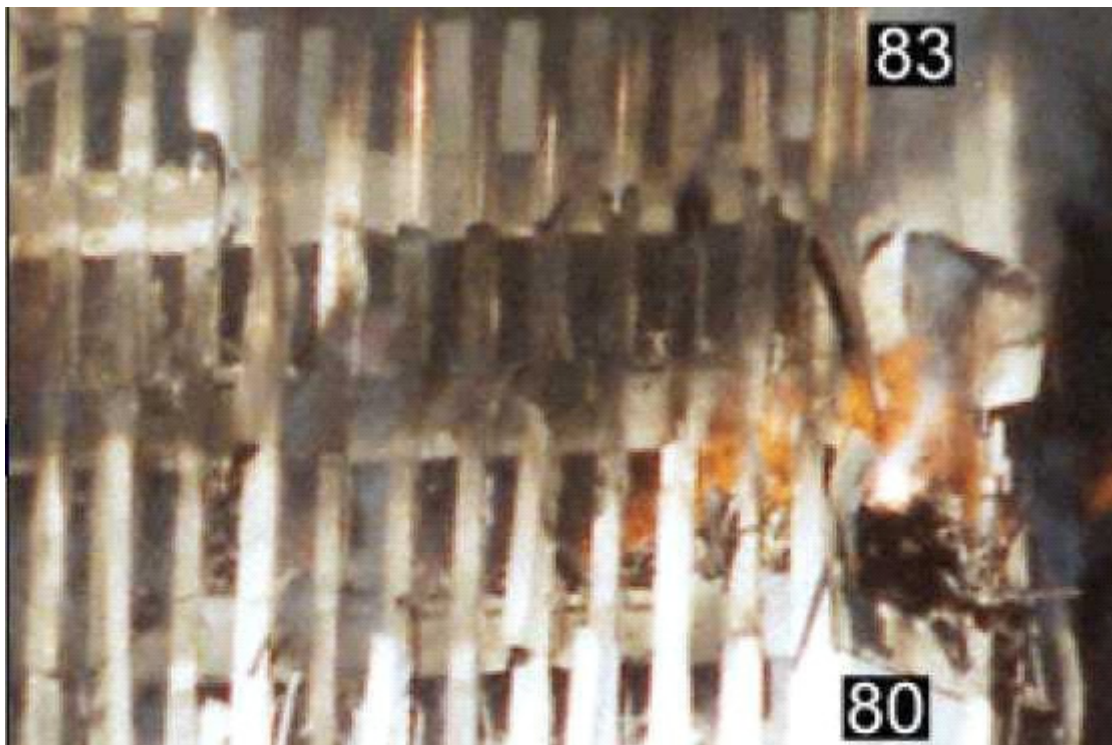
“An **unusual flame** is visible within this fire. In the upper photograph {Fig 9-44} a **very bright flame**, as opposed to the typical yellow or orange surrounding flames, which is **generating a plume of white smoke**, stands out.” Source: NCSTAR 1-5A Chapter 9 Appendix C NIST Fig. 9-44. p. 344

An intriguing photograph found as Figure 9-44 in the NIST report provides evidence for a highly exothermic reaction at the corner of the South Tower just minutes before its collapse. Furthermore, failure occurs at this very corner of the Tower as seen in this video footage:

Regarding this photo, NIST states:

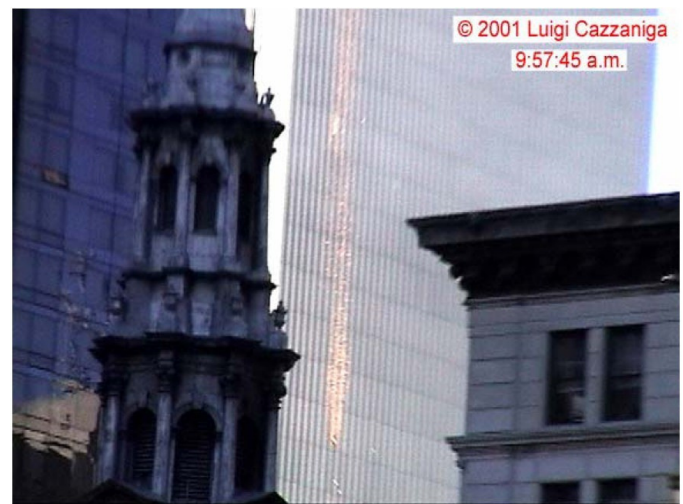
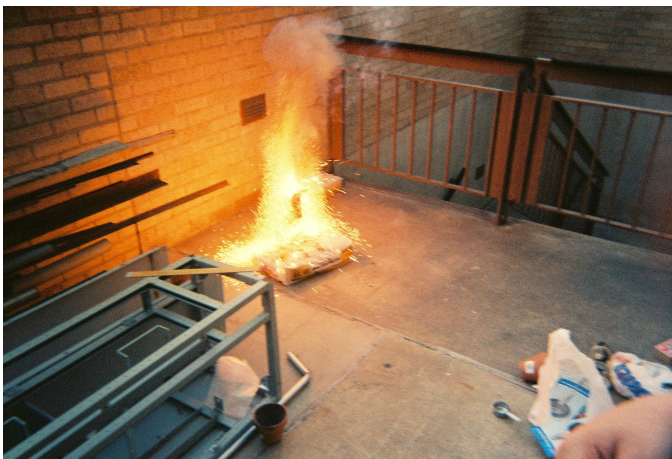
Is the falling molten metal from WTC Tower 2 (Top photos) more likely molten iron from a thermite reaction (lower left) OR pouring molten aluminum (lower right)?

Who can deny that liquid, molten metal existed at the WTC disaster? The yellow color implies a molten-metal temperature of approximately 1000 °C, evidently above that which the dark-smoke hydrocarbon fires in the Towers could produce. If aluminum (e.g., from the plane) had melted, it would melt and flow away from the heat source at its melting point of about 650 °C and thus would not reach the yellow color observed for this molten metal. Thus, molten aluminum is already ruled out with high probability. But molten iron with the characteristics seen in this video is in fact consistent with a thermite-reaction attacking the steel columns in the Tower, thus weakening the building just prior to its collapse, since thermite produces molten iron at yellow-to-white hot temperatures. (As some of the molten metal hits the side of the building in the video clip above, the white-hot interior is evidently exposed as the metal "splashes".) Also, the fact that the liquid metal retains an orange hue as it nears the ground (right photograph) further rules out aluminum, and suggests a mid-flight thermite reaction (typical of thermite). Here are two independent videos of the yellow-white liquid metal pouring out of the South Tower: <http://video.google.com/videoplay?docid=->

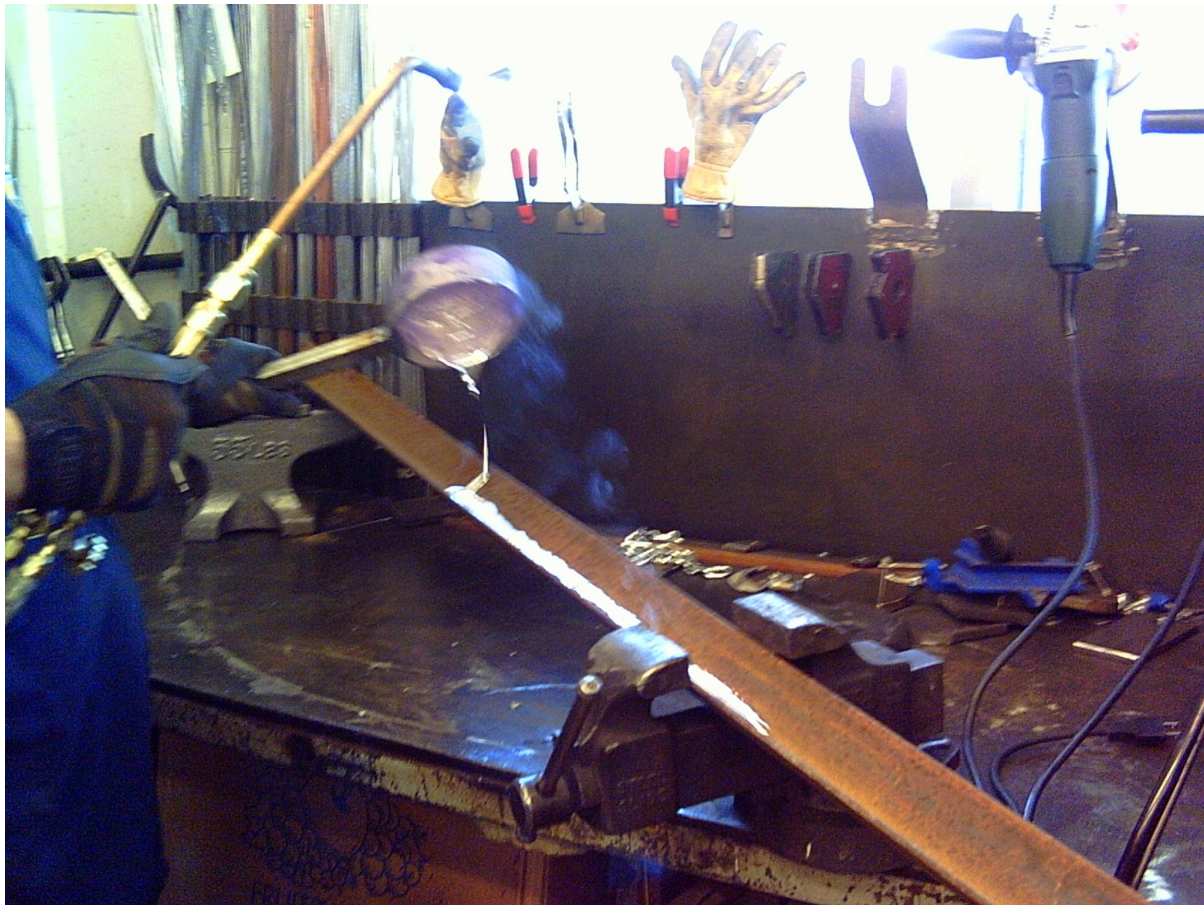
Molten aluminum poured onto rusted steel: silvery flow, and **no** violent reactions observed at all (contrary to predictions by some of a vigorous aluminum-rust “thermitic reaction”). Same result -- when the rusty steel piece was pre-heated with the torch.

We also noted that while a steel pan holding the aluminum glowed red and then yellow hot, when poured out the falling aluminum displayed a silvery-gray color, adding significantly to the evidence that the yellow-white molten metal flowing out from the South Tower shortly before its collapse was NOT molten aluminum. (Recall also that the yellow color of the molten metal (video clip above) implies a temperature of approximately 1100°C -- too high for the dark-smoke hydrocarbon fires burning in the building.) This is a point worth emphasizing: aluminum has low emissivity and high reflectivity, so that in daylight conditions after falling through air 1-2 meters, molten aluminum will appear silvery-gray, while molten iron (with its characteristic high emissivity) will appear yellow-white (at ~1100°C) as observed in the molten metal dripping from the South Tower just before its collapse (see: <http://www.supportthetruth.com/jones.php>). We also recall that this molten metal, after falling approximately 150 meters (or yards) still retained a reddish orange color (photograph above). This is not the behavior of falling, molten aluminum.

NIST states the hypothesis that flowing aluminum with partially burned organic materials mixed in, "can display an orange glow." But will it really do this? I decided to do an experiment to find out. Our group melted aluminum in a steel pan using an oxy-acetylene torch. Then we added plastic shavings -- which immediately burned with a dark smoke, as the plastic floated on top of the hot molten aluminum. Next, we added wood chips (pine, oak and compressed fiber board chips) to the liquid aluminum. Again, we had fire and smoke, and again, the **hydrocarbons floated on top** as they burned. We poured out the aluminum and all three of us observed that it appeared silvery, not orange! We took photos and videos, so we will have the recorded evidence as these are processed. Of course, we saw a few burning embers, but this did not alter the silvery appearance of the flowing, falling aluminum.

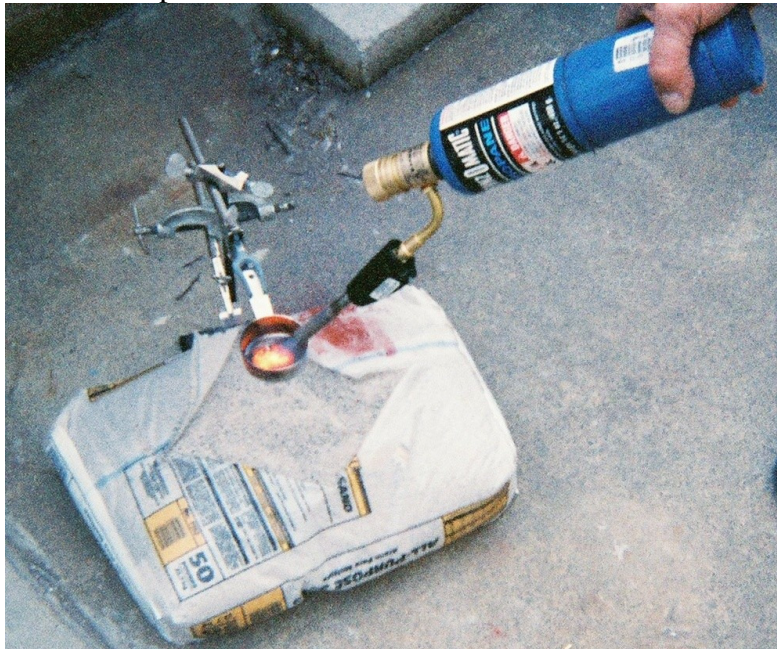
Thermite did not ignite when heated with a propane torch.

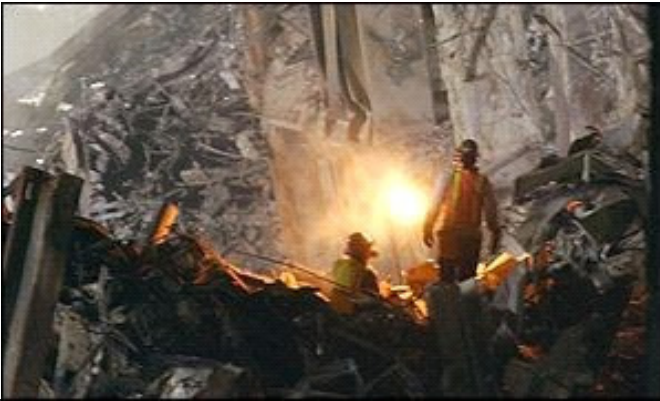
The top photo (<http://news.bbc.co.uk/2/hi/science/nature/1858491.stm>) may show the glow of hot metal in the rubble; the second photo clearly does so. It is labeled "Red Hot Debris" and is published in **LiRo News, Nov. 2001**, <http://www.liro.com/lironews.pdf> . Moreover, there is recorded eyewitness testimony of the molten metal pools under both Towers and WTC 7; see: <http://georgewashington.blogspot.com/2005/12/why-was-there-molten-metal-under.html> . Video clips provide eye-witness evidence regarding this metal at ground zero: http://plaguepuppy.net/public_html/video%20archive/red_hot_ground_zero_low_quality.wmv , <http://video.google.com/videoplay?docid=-3060923273573302287> .

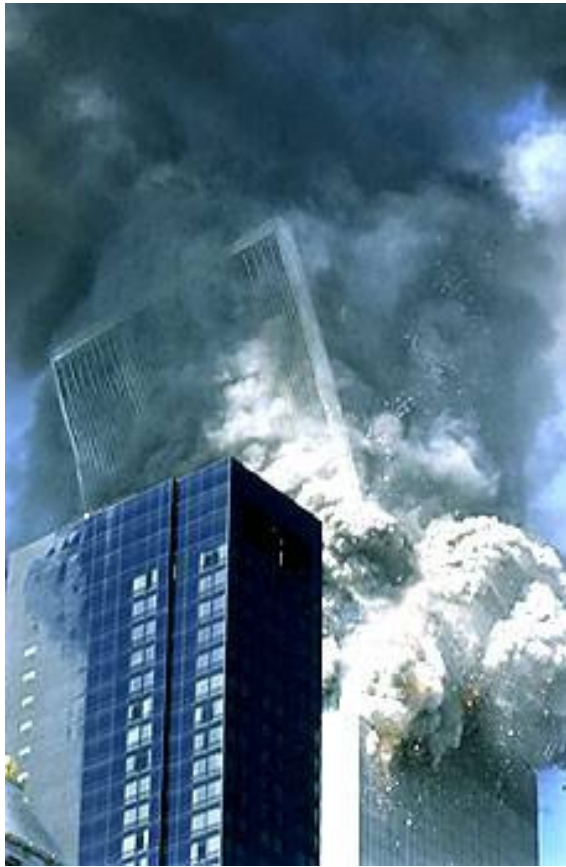
Top ~ 30 floors of South Tower topple over.
What happens to the block and its angular momentum?

We observe that approximately 30 upper floors begin to rotate as a block, to the south and east. They begin to topple over, not fall straight down. The torque due to gravity on this block is enormous, as is its angular momentum. But then – and this I’m still puzzling over – this block turned mostly to powder *in mid-air*! How can we understand this strange behavior, without explosives? Remarkable, amazing – and demanding scrutiny since the US government-funded reports failed to analyze this phenomenon. But, of course, the Final NIST 9-11 report “**does not actually include the structural behavior of the tower after the conditions for collapse initiation were reached.**” (NIST, 2005, p. 80, fn. 12; emphasis added.)

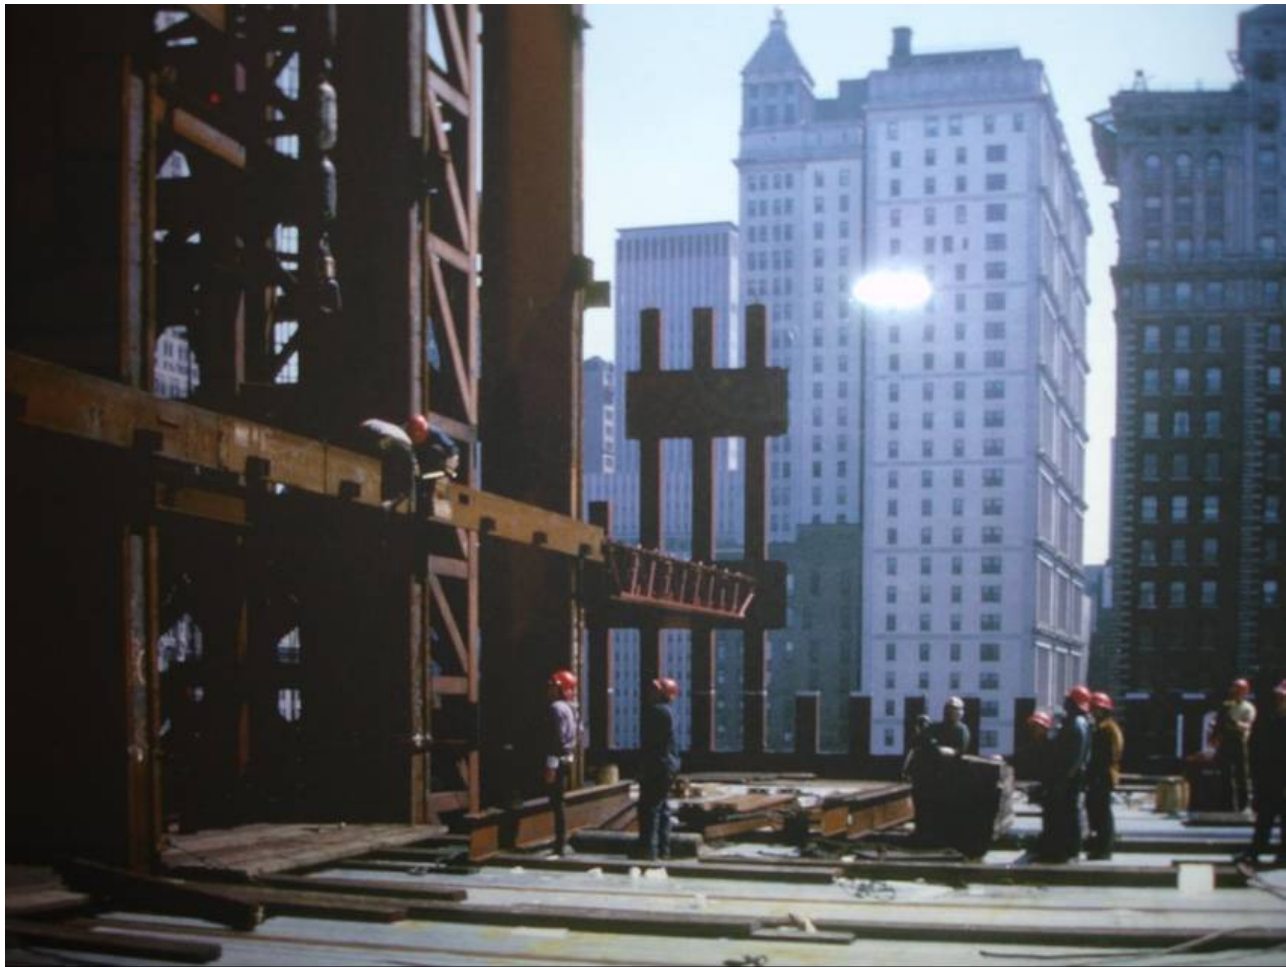
Steel-frame: Huge core (left) is an enormous heat sink. Notice workers standing on floor pan which is firmly attached to the interconnected core columns. Clearly, **the Towers were not “hollow tubes.”**
